Bears & Barriers

Capitalizing on Natural Ecology to Benefit Yellowstone Cutthroat Trout

A recently-completed fish passage project in the Greater Yellowstone Ecosystem is using Tygee Creek's natural ecology to benefit a genetically unique population of Yellowstone cutthroat trout. With the

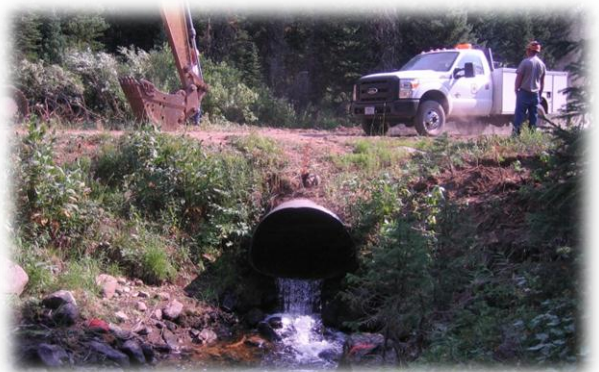
Before: The existing 36-inch pipe culvert on Tygee Creek prevented Yellowstone cutthroat trout from migrating upstream to spawn. Photo Credit: USFWS

The first improvement was completed in 1999 with the replacement of one culvert. The final component of the project was completed in 2012 when the Caribou-Targhee National Forest and the Service replaced the second culvert. The 2012 work also addressed other habitat concerns by making road improvements that minimize the amount of sediment that washes into Tygee Creek. Now that the job is finally done, the Tygee population of Yellowstone cutthroat trout can enjoy the full range of upper Tygee Creek.

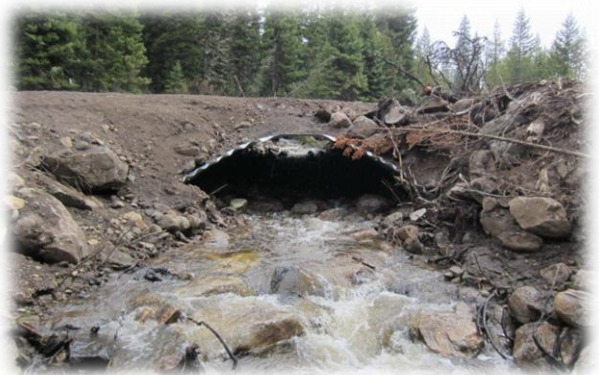
Now: Replacing the existing culvert with an 18-foot bottomless arch culvert allows fish to swim more freely because the bottom of the culvert is natural stream bed. Photo Credit: USFWS
